# MS-6332 Flex-ATX

Intel PPGA 370 Processor

Intel 815E ( Solano2 ) Chipset

MS6332 Ver:50C Golden Sample 7/12/2001

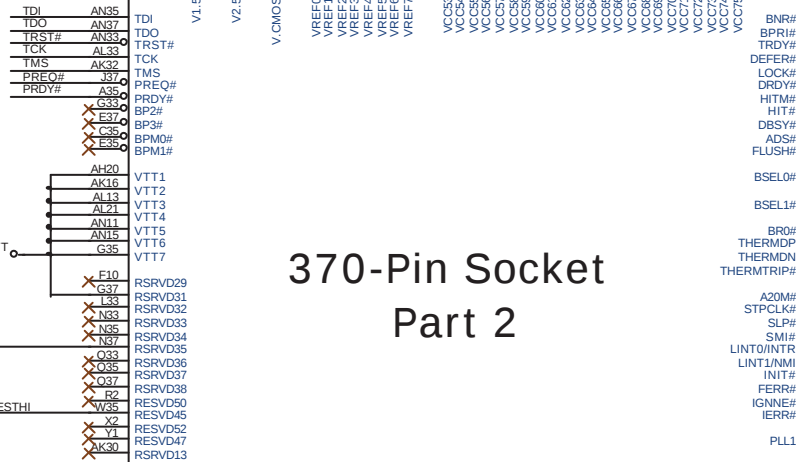
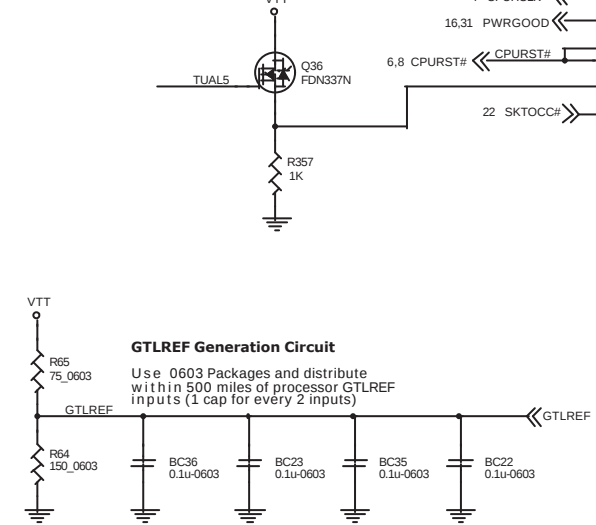
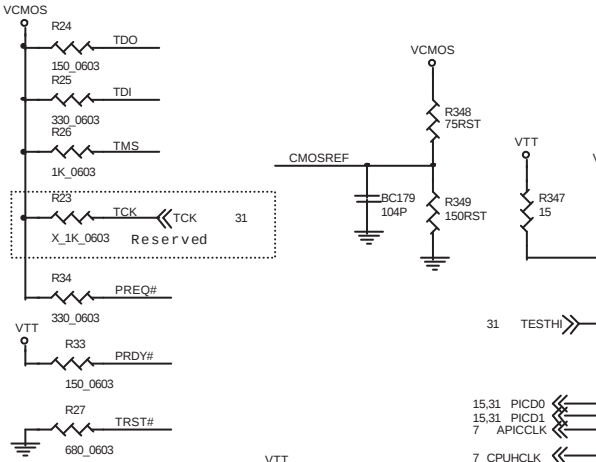
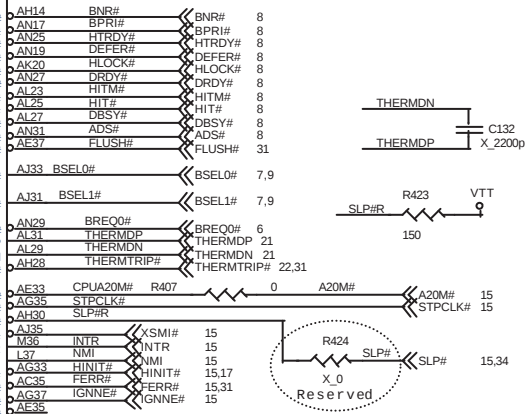
## 370PGA Socket Part 2

### FOR ITP TEST VIA

Pin AF36  
CumIn= GND  
Tualatin= NC

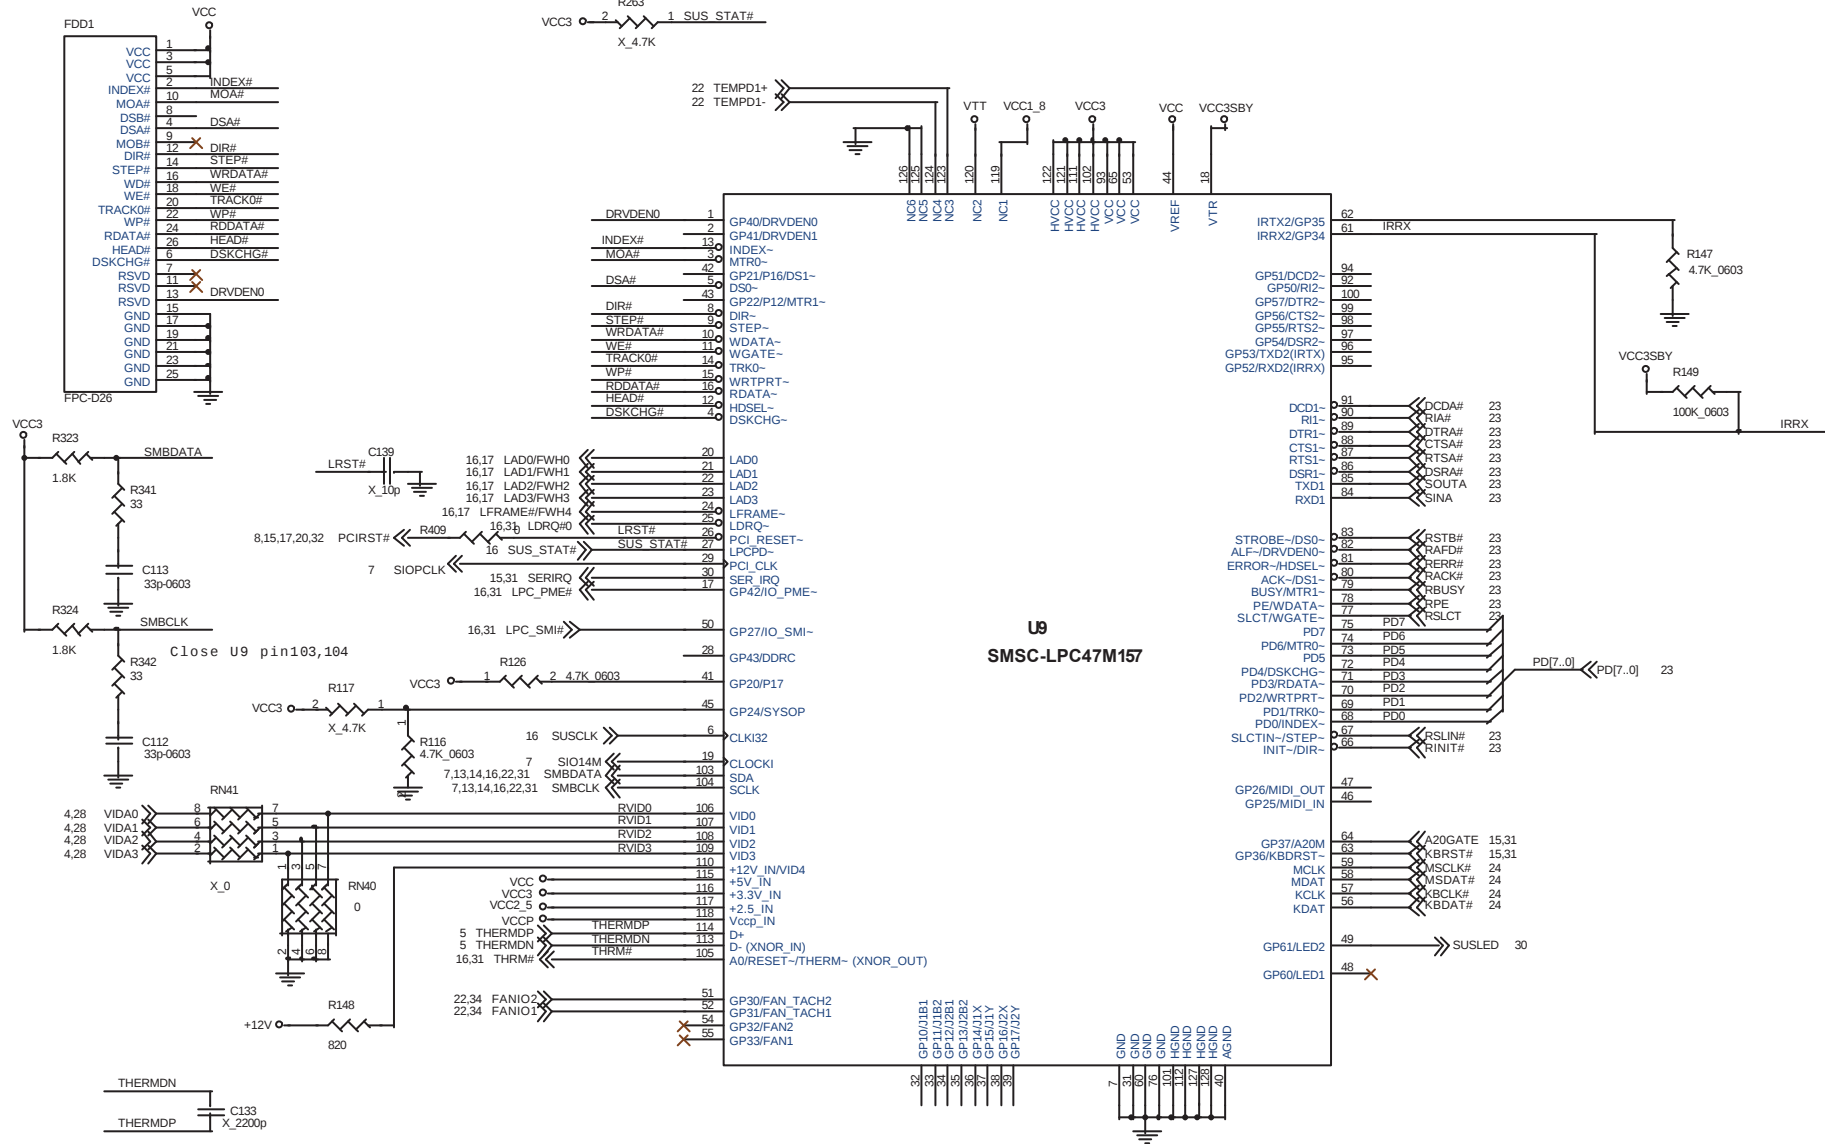
## FLOPPY DISK HEADER

| SIO ADDRESS | |
| R116 | 2E |
| R117 | 4E |

| Title | Page |
|---|---|
| LPC I/O | 21 |
