Installing Brother HL-5240 Laser Printer Toner Cartridge

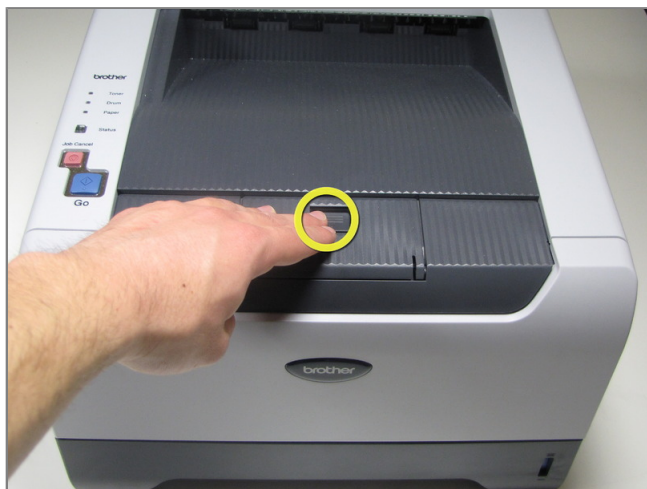
Step 1 - repair Drum Unit and Toner Cartridge

- Press the front cover release button.
- Keep the button pressed and pull the cover toward yourself.

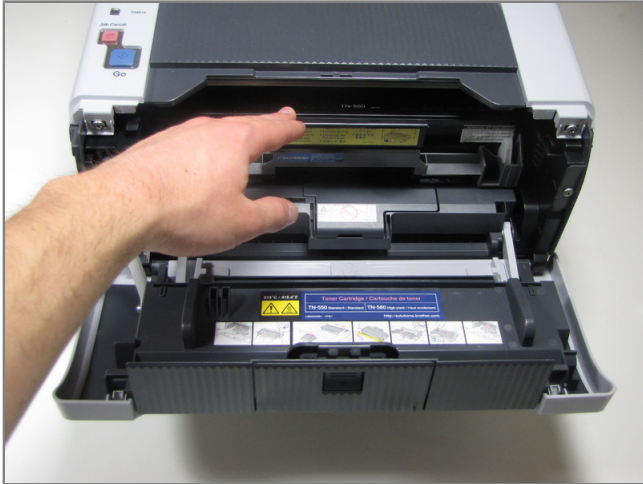
Step 2

- With the front cover in the downward position, the drum & toner unit will be visible.
- Grab the black-and-yellow handle on the unit. Lift unit up and pull it out of the printer.

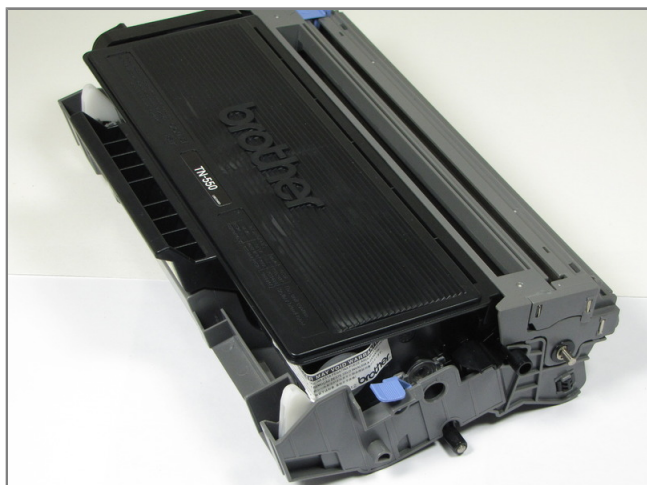
Step 4

- Insert the toner cartridge into the new drum break by firmly sliding the cartridge into the drum unit. If installed correctly, the blue lever will be locked in a lifted position.
- Be sure that the black nob located on the back of the toner cartridge is placed inside the track located on the drum unit.
- The third picture illustrates an incorrectly installed drum unit and toner cartridge, notice how the blue lever is down.
